Impact Testing of a Proximal Femur in a Fall Configuration

Gilchrist S^{1,2,3,†}, Guy P^{3,4}, Cripton P^{1,2,3,4}

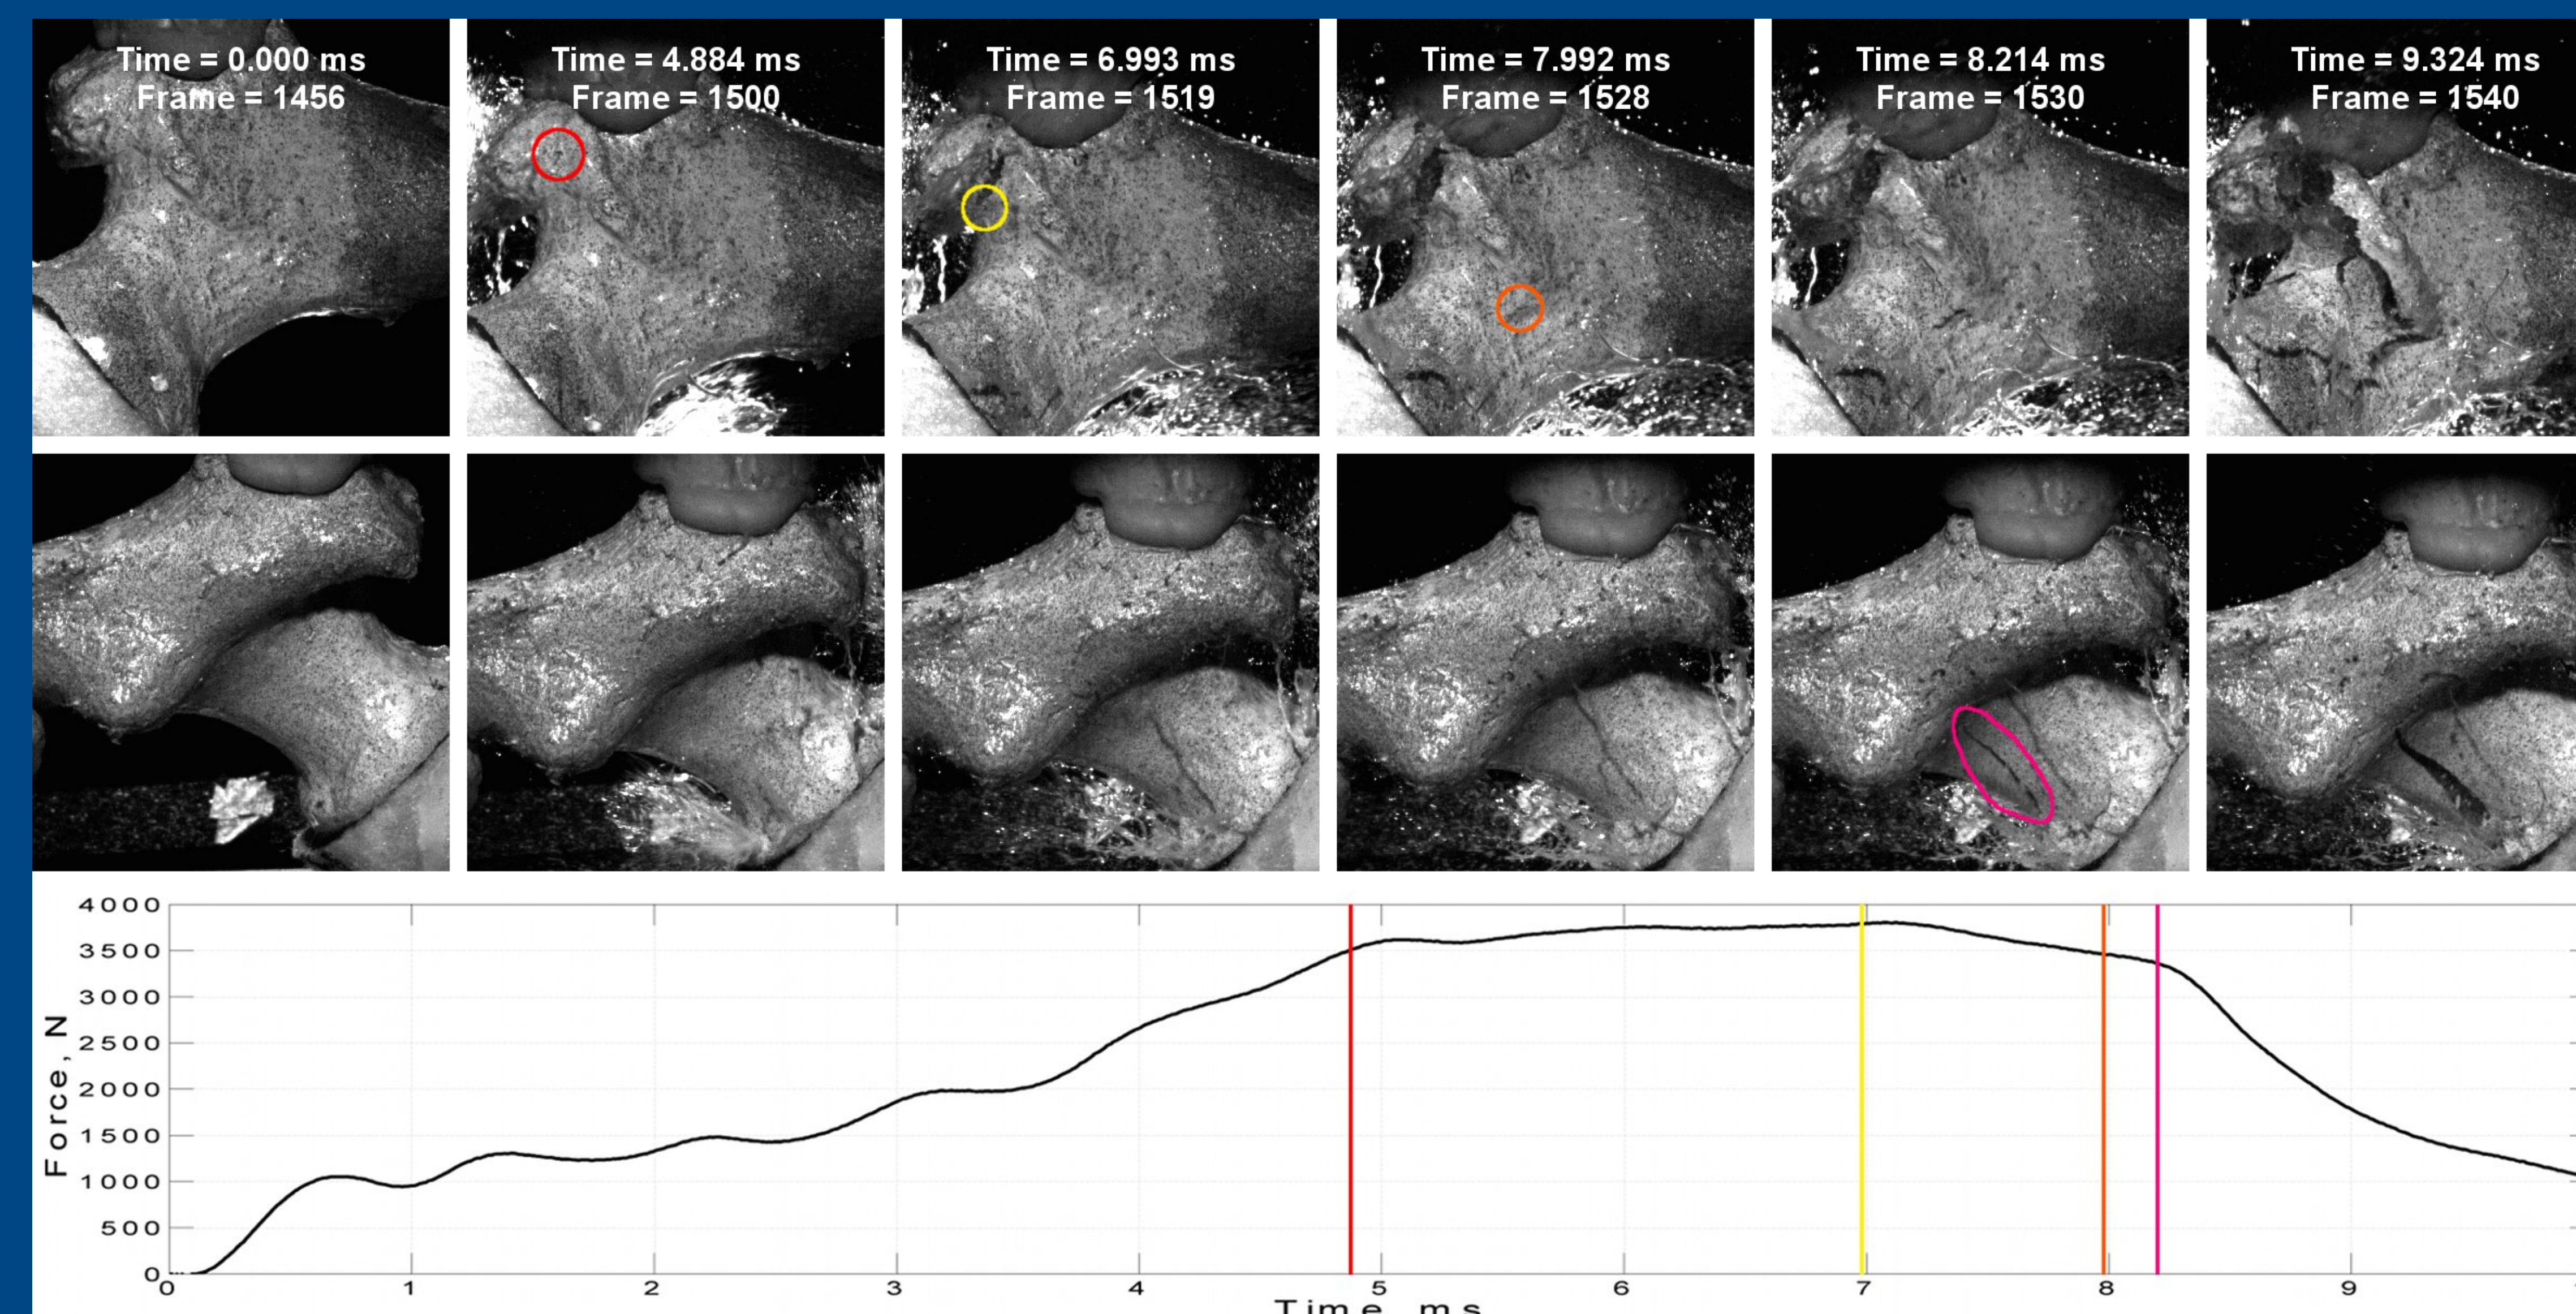
Figure 2: High speed fracture sequence. Top row of images shows the anterior camera and the bottom row is the posterior camera. Circles on the top row images correspond to fracture events and are indicated on the force vs time trace on the bottom.
The fracture began at 3520 N at 4.88 ms in the greater trochanter. The load plateaued, but continued to increase until 3800 N at 6.99 ms when another fracture progressed along the superior femoral neck. At this point, the load began to decrease and general yielding was observed lateral to the trochanteric line. At 7.99 ms a crack opened on the anterior surface of the neck, passing through a vascular perforation. This was shortly accompanied by a fast-moving crack on the posterior neck and a precipitous drop in load carrying capacity. Finally, a highly comminuted fracture resulted.

- Femur was impacted at the desired energy and velocity
- Fracture began at 4.88 ms after impact and continued for 3.33 ms (Fig 2)
